Manhole Inspection Summary

Manhole # S39S__029MH

Page 1 of 3

Location Address: **1411 jackson st**

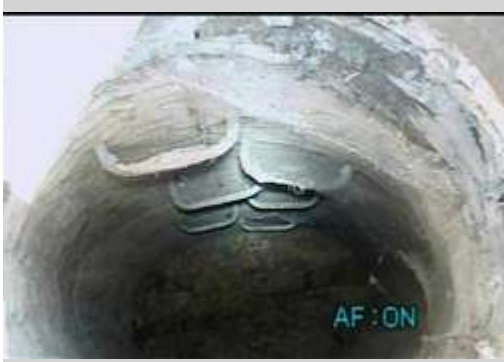
Defect 1

Condition: ☐ Sound ☐ Cracked ☐ Root Intrusion ☒ **Loose Brick** ☒ **Deteriorated**

deteriorated corbel corroded steps

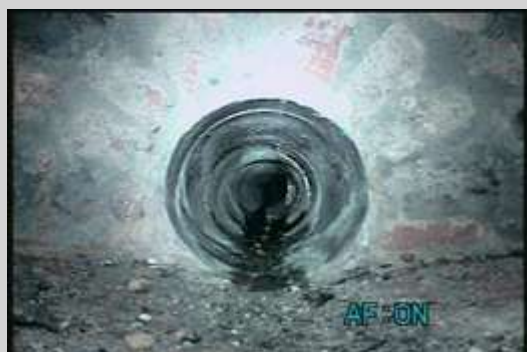
12 O'Clock Outflow

8 in. Circular Gravity Sewer
Pipe Out @ 12 O'Clock
